White Paper

Managing Fire Sprinkler System Risk in a Mission Critical Data Center Setting

Important Questions to Ask

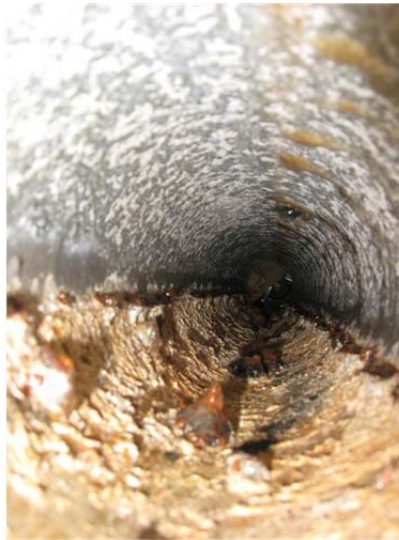
Evidence of trapped water in piping

The National Fire Protection Association (NFPA) requires that all dry and preaction fire sprinkler systems be hydrostatically tested before they are commissioned for service. The result of this necessary exercise is that there are always small pools of trapped water in the fire sprinkler piping. It is virtually impossible to drain out all of the water after the test. Additional amounts of water are added to the piping during periodic system testing (also required by the NFPA). A third source adds moist air each time the pressure maintenance compressor clicks on to keep the piping pressurized. The moisture in the air eventually condenses to produce condensate water within the piping. Until the 2007 edition of the installation standard for fire sprinkler systems, NFPA 13 did not require preaction fire sprinkler systems be “pitched” to allow draining of trapped water from the piping. This means that most preaction systems

Corrosion cannot occur without liquid water. In the case of preaction fire sprinkler pipes, all of the necessary elements are present: the steel piping, water and plenty of oxygen. Corrosion is inevitable in these systems and depending on the number of trapped pools of water, the amount of water and the amount of oxygen the corrosion rates can be quite high.

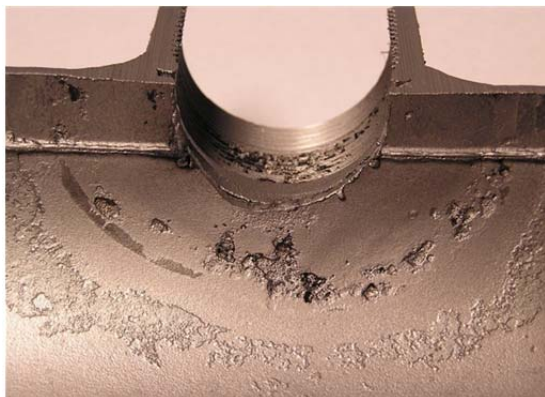
Anodic hot spot due to weld-o-let installation

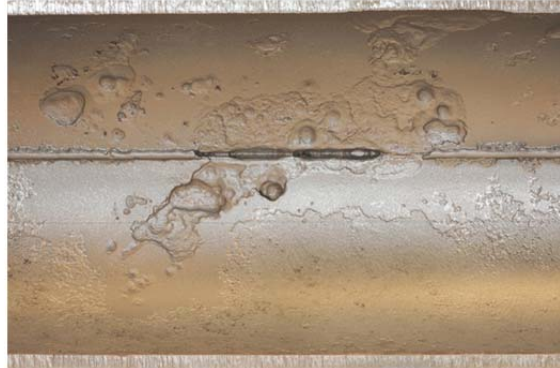
Knife cut corrosion on submerged weld seam
(galvanized steel pipe)

Another factor contributing to corrosion related leaks is the lack of heat annealing of the weld seam on fire sprinkler piping. The current ASTM Standards for the fire sprinkler industry do not require that the weld seams be heat annealed, the result is that the piping is subject to “knife cut” corrosion wherein the weld metal and the heat affected zone adjacent to the weld

corrode preferentially to the rest of the pipe. If the weld seam happens to end up installed under trapped water, failures in schedule 10 galvanized steel piping have occurred in as little as 12 months.
